Manhole Inspection Summary

Manhole # S25C1_010MH

Insp Date: **4/14/08 2:16 PM**

Location Address: **MAISEL ST.**

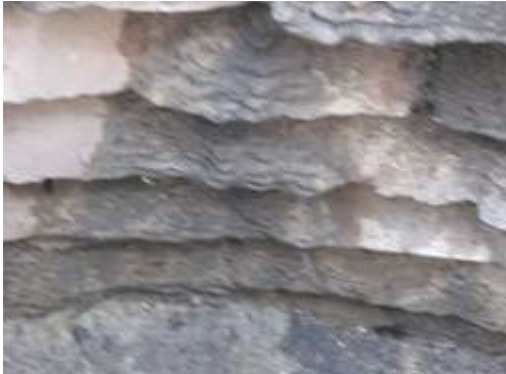
Defect 2

Corbel Material: **Brick** ☐ Parged Type: **Concentric/Eccentric**

Infiltration: ☐ None ☐ Joint ☐ Cracks ☒ **Mortar** ☐ Roots ☐ Wall

Barrel Material: **Brick** ☐ Parged

EVIDENCE OF CORBEL AND BARREL INFILTRATION AT MORTAR

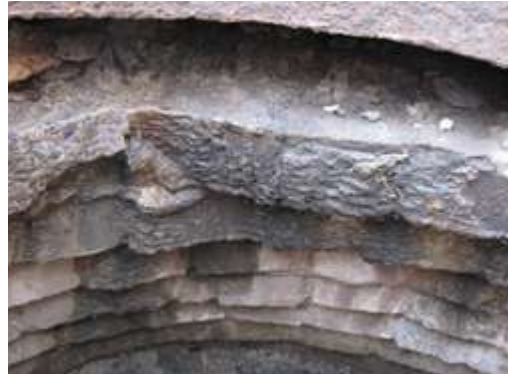
Defect 1

Chimney / Frame Adjustment ☒ Exists Material: **Brick** ☐ Parged Height: **3** (in.)

Condition: ☐ Sound ☐ Cracked ☐ Root Intrusion ☒ **Loose Brick** ☐ Deteriorated

Infiltration: ☐ None ☐ Joint ☐ Cracks ☒ **Mortar** ☐ Roots ☐ Wall

EVIDENCE OF CHIMNEY INFILTRATION, MISSING MORTAR AND BRICK

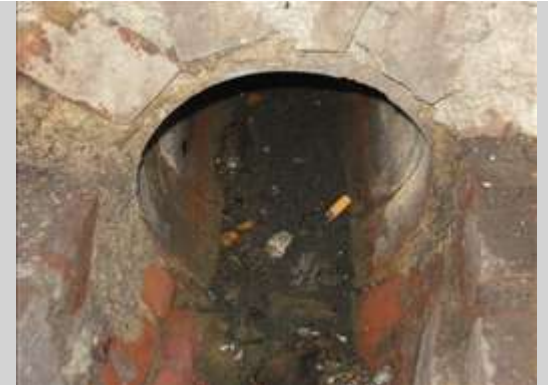
12 O'Clock Outflow

8 in. Circular Gravity Sewer
Pipe Out @ 12 O'Clock

Pipe Height: **8.4** (in.) Rod and Bar (Angled)
Pipe Material: **Clay** ☐ Pipe Lined
Invert Depth: **3.21** (ft.) Flow Characteristics: **None**
Deposits: ☒ None ☐ Mud ☐ Sludge ☐ Debris ☐ Grease
Silt Depth: **0** (in.) Deposits Extent:
Infiltration: **None** Pipe Seal Cond: **Sound**

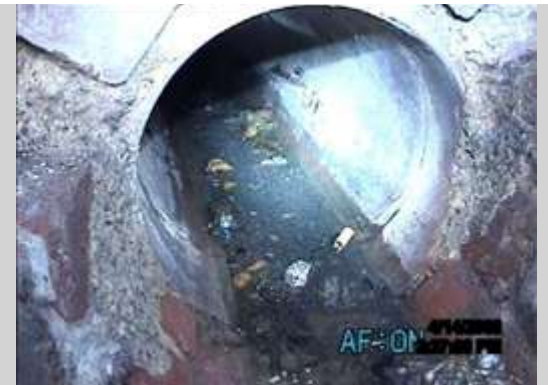
3 O'Clock Inflow

8 in. Circular Gravity Sewer
Pipe In @ 3 O'Clock

Pipe Height: **8.4** (in.) Rod and Bar (Angled)
Pipe Material: **Clay** ☐ Pipe Lined
Invert Depth: **3.07** (ft.) Flow Characteristics: **None**
Deposits: ☒ None ☐ Mud ☐ Sludge ☐ Debris ☐ Grease
Silt Depth: **0** (in.) Deposits Extent:
Infiltration: **None** Pipe Seal Cond: **Sound**
